Shown here is the surface of a new Rover Wheel from the 2009 FRC kit of parts. Notice that its finish is unmarred, shiny and slick:

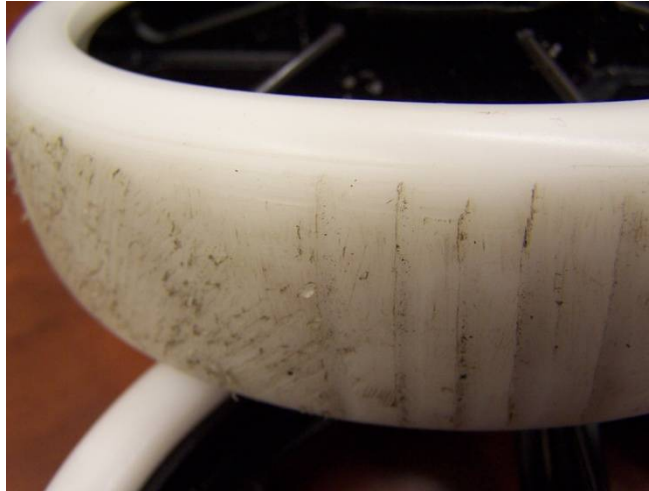
In contrast, here is a wheel that has been intentionally (illegally) modified to alter its traction:

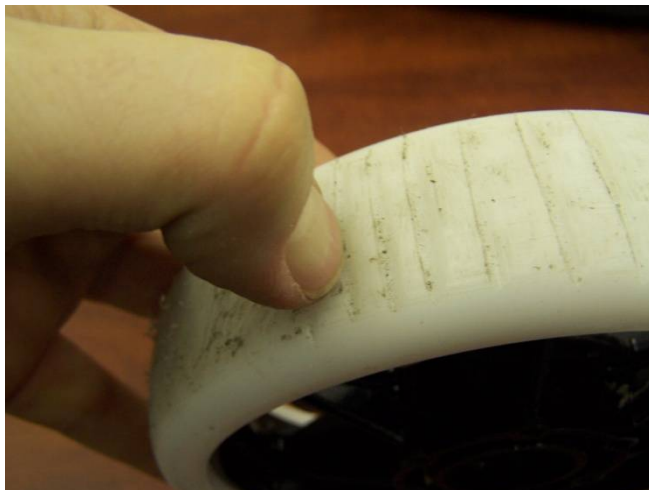
One good and quick way to determine the extent to which a wheel has been roughened is to use a fingernail (the "Thumbnail Test") as shown. If your nail catches on ridges or burrs, it's too rough:

Once cleaned, perform the "thumbnail test" once more to ensure there are no major ridges, burrs or other surface imperfections that can change the traction.

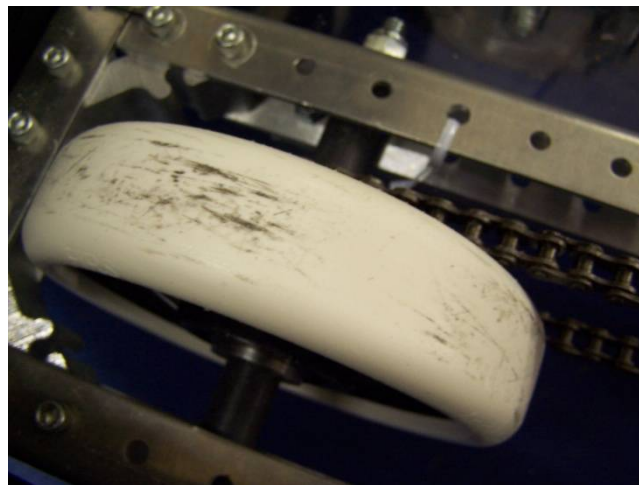
If not used to excess (as in producing a pile of white dust on the floor!), the results should be good, as shown in this partial job:
